**Re: Concrete Slab Investigation – Moisture Vapour Emissions Rate Testing Report**  
Dr. John Hugh Gillis High School, 105 Braemore Avenue, Antigonish, Nova Scotia  
Pinchin File: 01-05-00479

Pinchin LeBlanc Environmental Limited (Pinchin) was retained by the Strait Regional School Board (Client) to investigate concrete slab conditions within the basement level of Dr. John Hugh Gillis High School, located at 105 Braemore Avenue, Antigonish, Nova Scotia (Site Building).

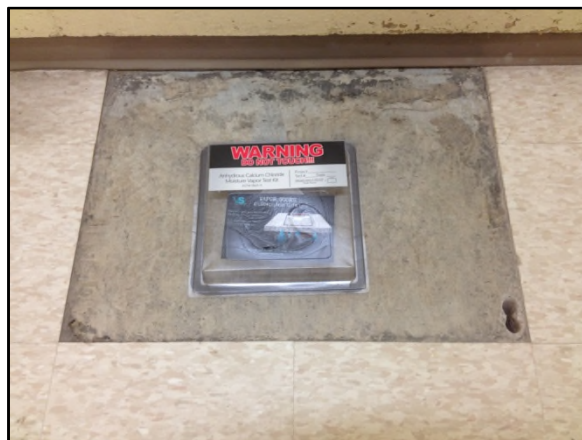
View of a typical test area (as shown within the stairwell).
