**Re: Limited Mould Assessment and Bulk Asbestos Sampling**  
Dr. John Hugh Gillis Regional High School – Antigonish, Nova Scotia

**Limited Mould Assessment & Bulk Asbestos Sampling**

Dr. John Hugh Gillis Regional High School – Antigonish, NS  
Strait Regional School Board

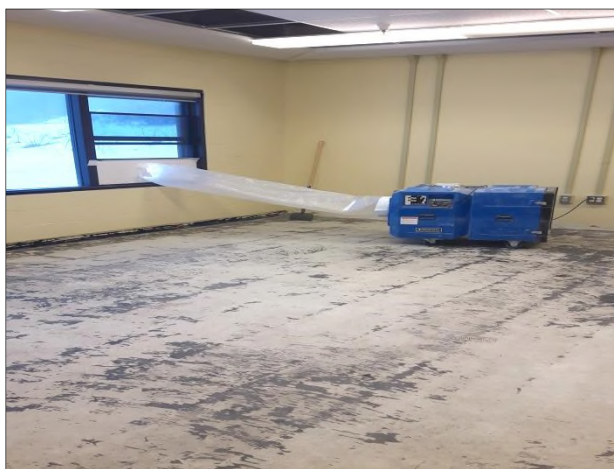
A strong musty odour was noted in Classroom 1010 on the assessment day. Signs of visible mould growth were not noted in Classroom 1010. Efflorescence was noted on the concrete sub floor. The efflorescence was noted to be outlining the location of the seams of the recently removed floor tiles. Elevated moisture readings were measured on the concrete floor. Elevated moisture readings were not measured about one foot out from each of the exterior walls. This is likely due to the presence of a frost wall that was reported to extend approximately one foot past the exterior walls.

**Photo 1** – General view of Classroom 1010 on the assessment day.

Pinchin recommends that thorough inspections be conducted of the building envelope surrounding Classroom 1010 including the exterior drainage system of the building for potential pathways for water and/or odours.

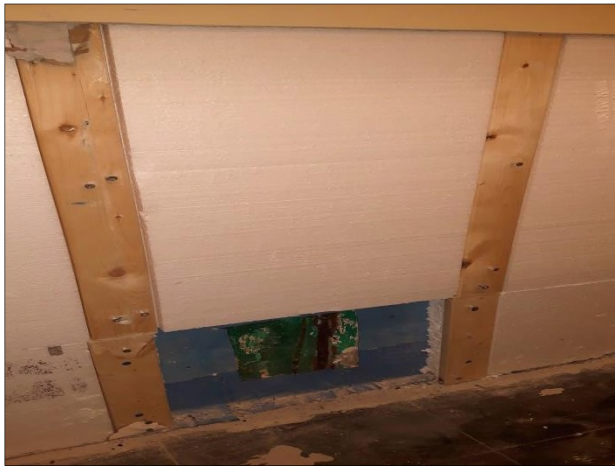
A visual assessment for signs of visible mould growth and water damage was conducted in Classroom 1010. At the time of the assessment the floor tiles had been removed from the floor exposing the concrete sub floor. In addition various sections of drywall had been removed and some ceiling tiles had been removed.

**Photo 2** – View of exterior wall with a section of drywall removed.

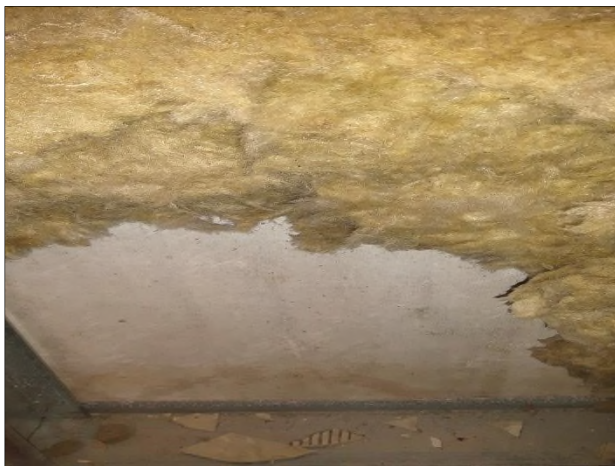
**Photo 3** – View of interior wall with section of drywall removed.

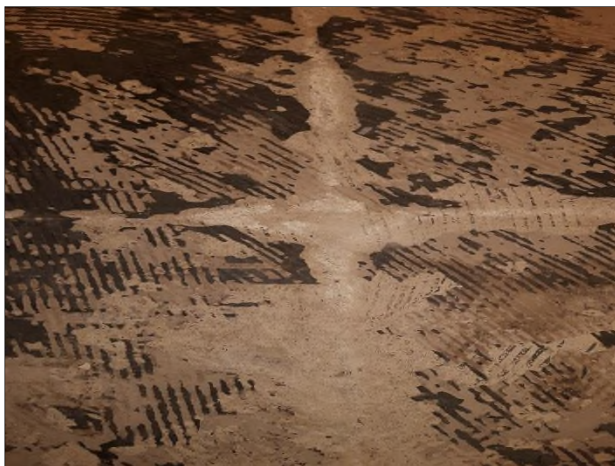
**Photo 4** – View of efflorescence on the concrete subfloor.

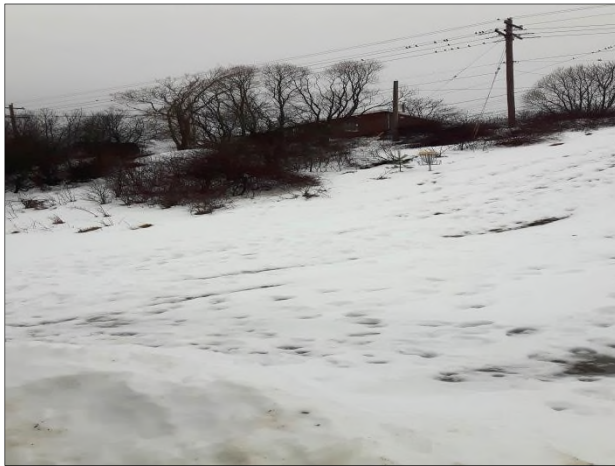
On the exterior of the building a hill was noted to be sloping towards the north exterior wall of Classroom 1010. The exterior slop of the land immediately adjacent to the building tends to slope northwest.

**Photo 5** – View of slope of land on the north side of Classroom 1010.

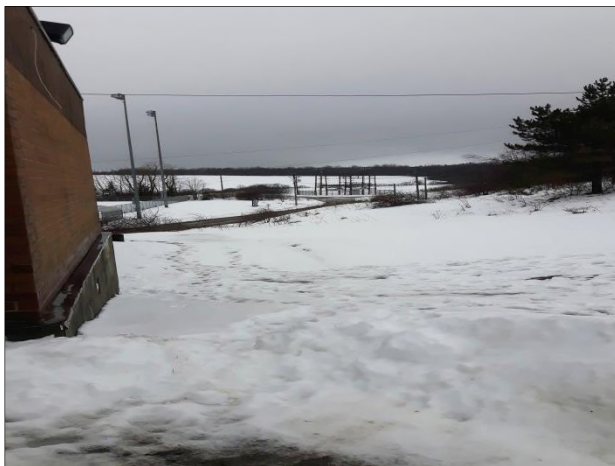
**Photo 6** – View of slope of land looking north west.
